THE
GREAT EARTHQUAKE
OF JAPAN

1891.

BY
JOHN MILNE.
AND
W.K. BURTON.
PLATES BY K. OGAWA.

JOHN MILNE, F.R.S. PROFESSOR OF MINING AND GEOLOGY ; IMPERIAL UNIVERSITY OF JAPAN,

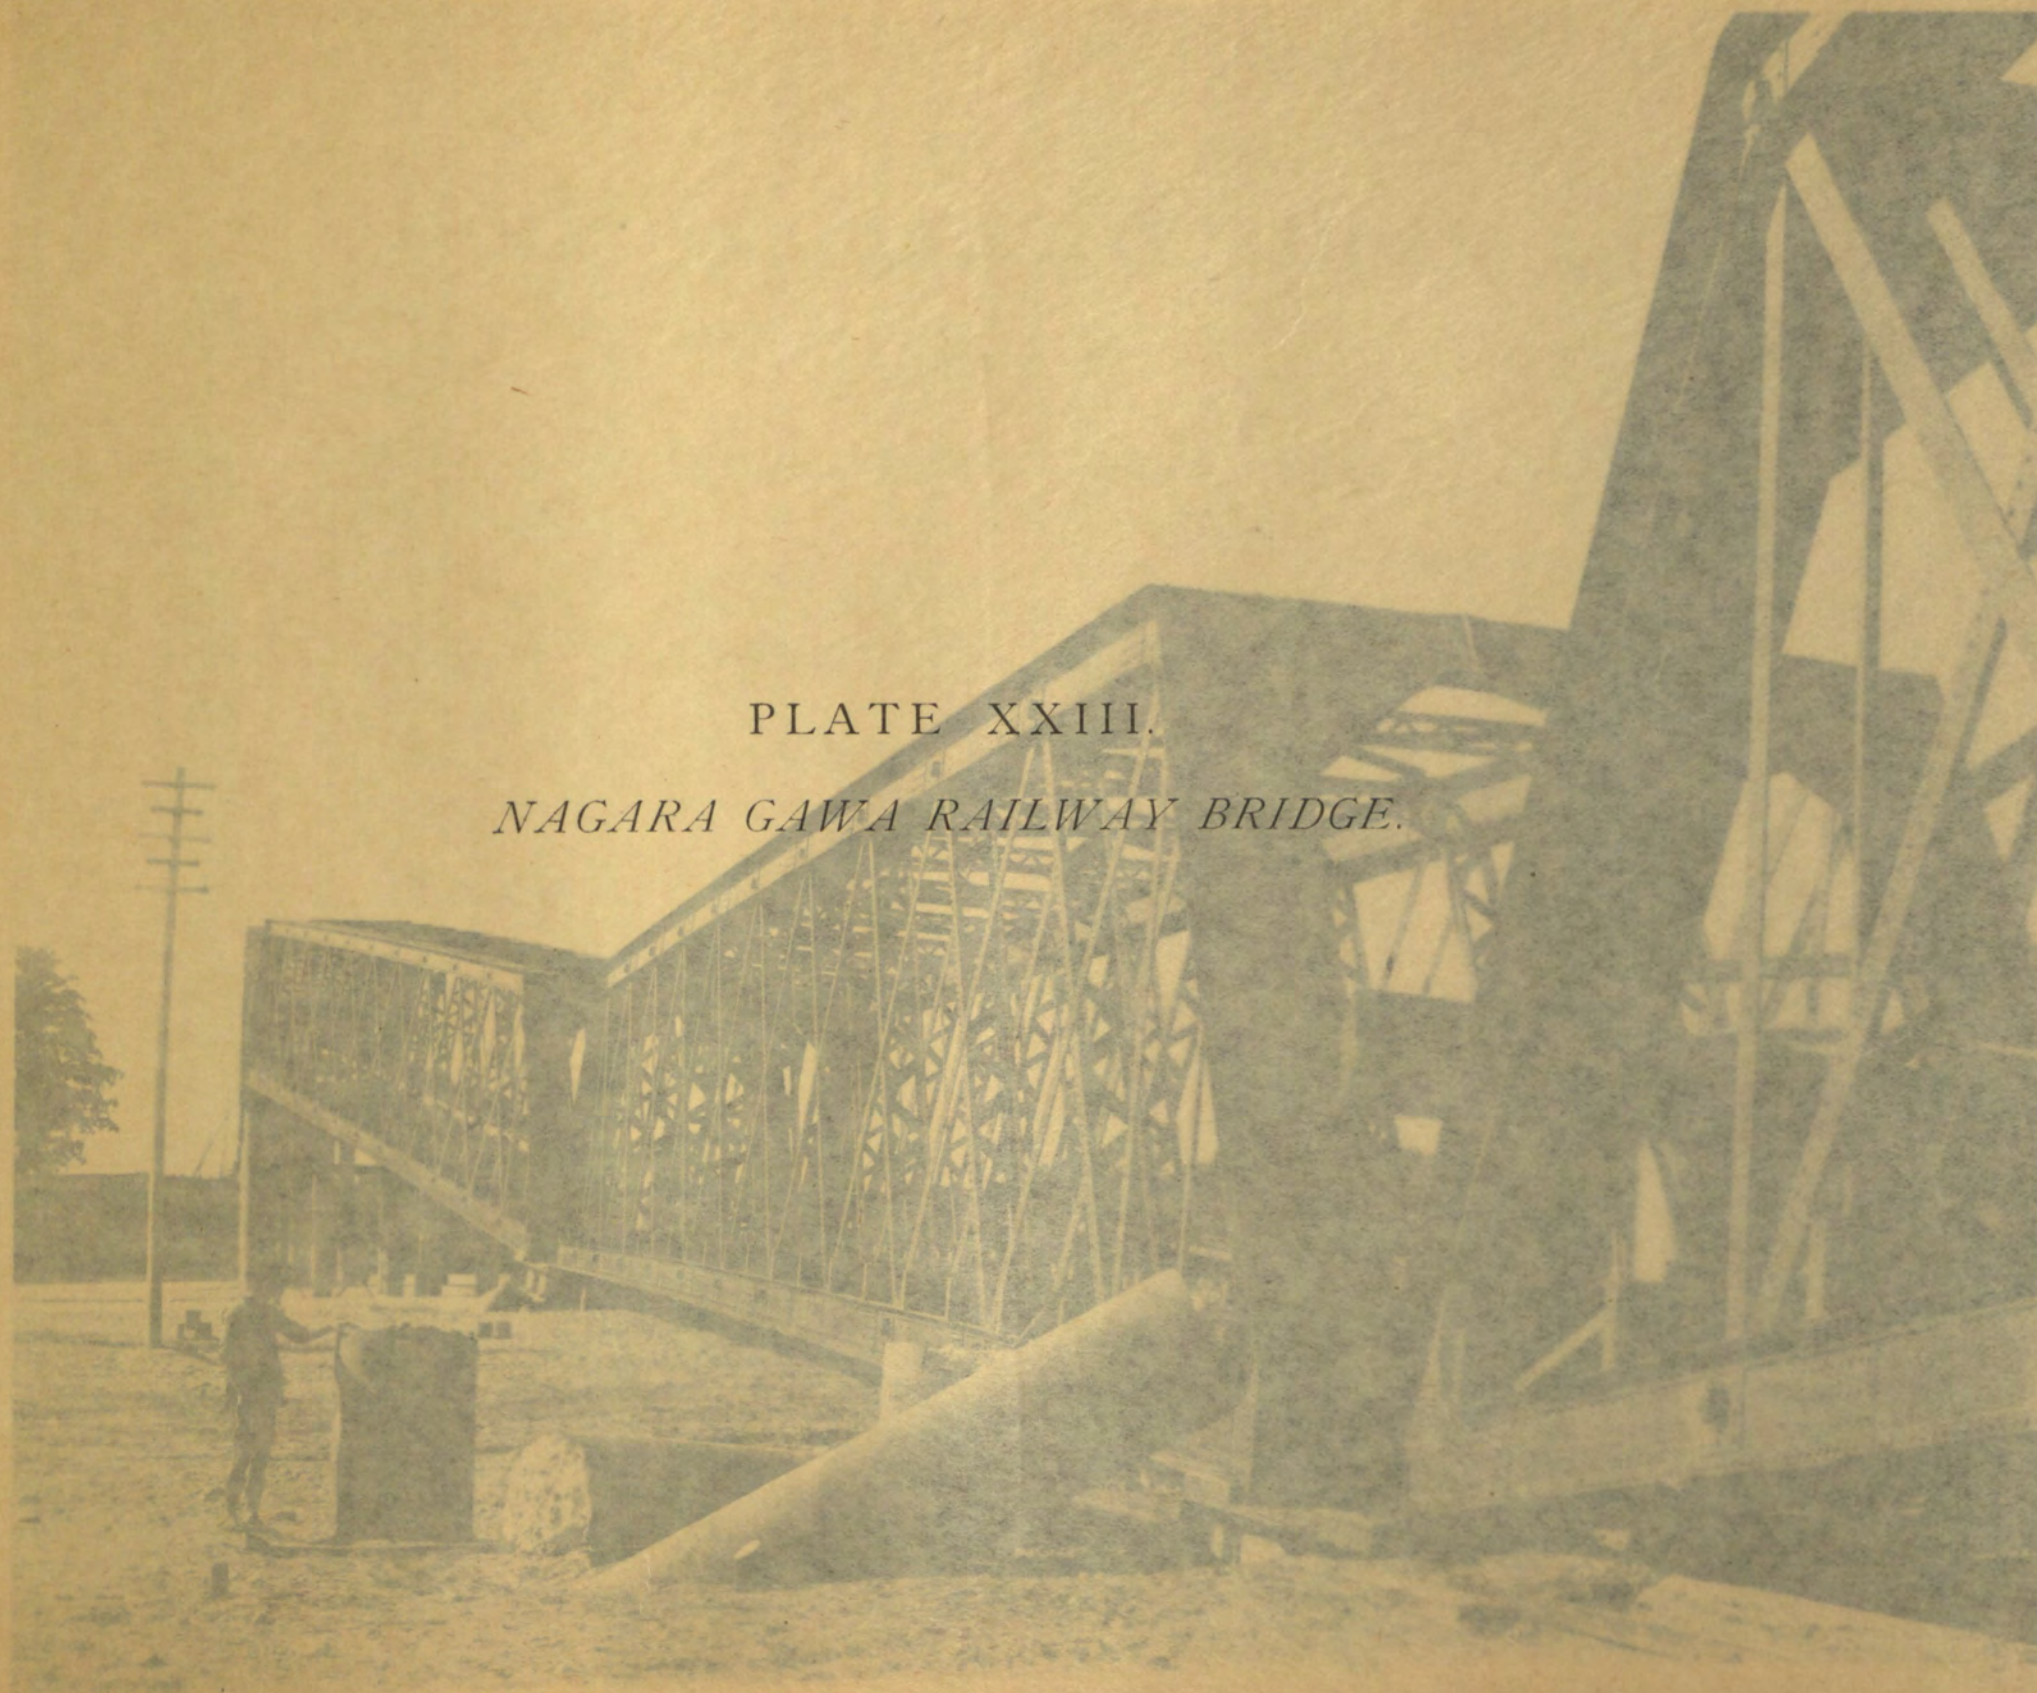
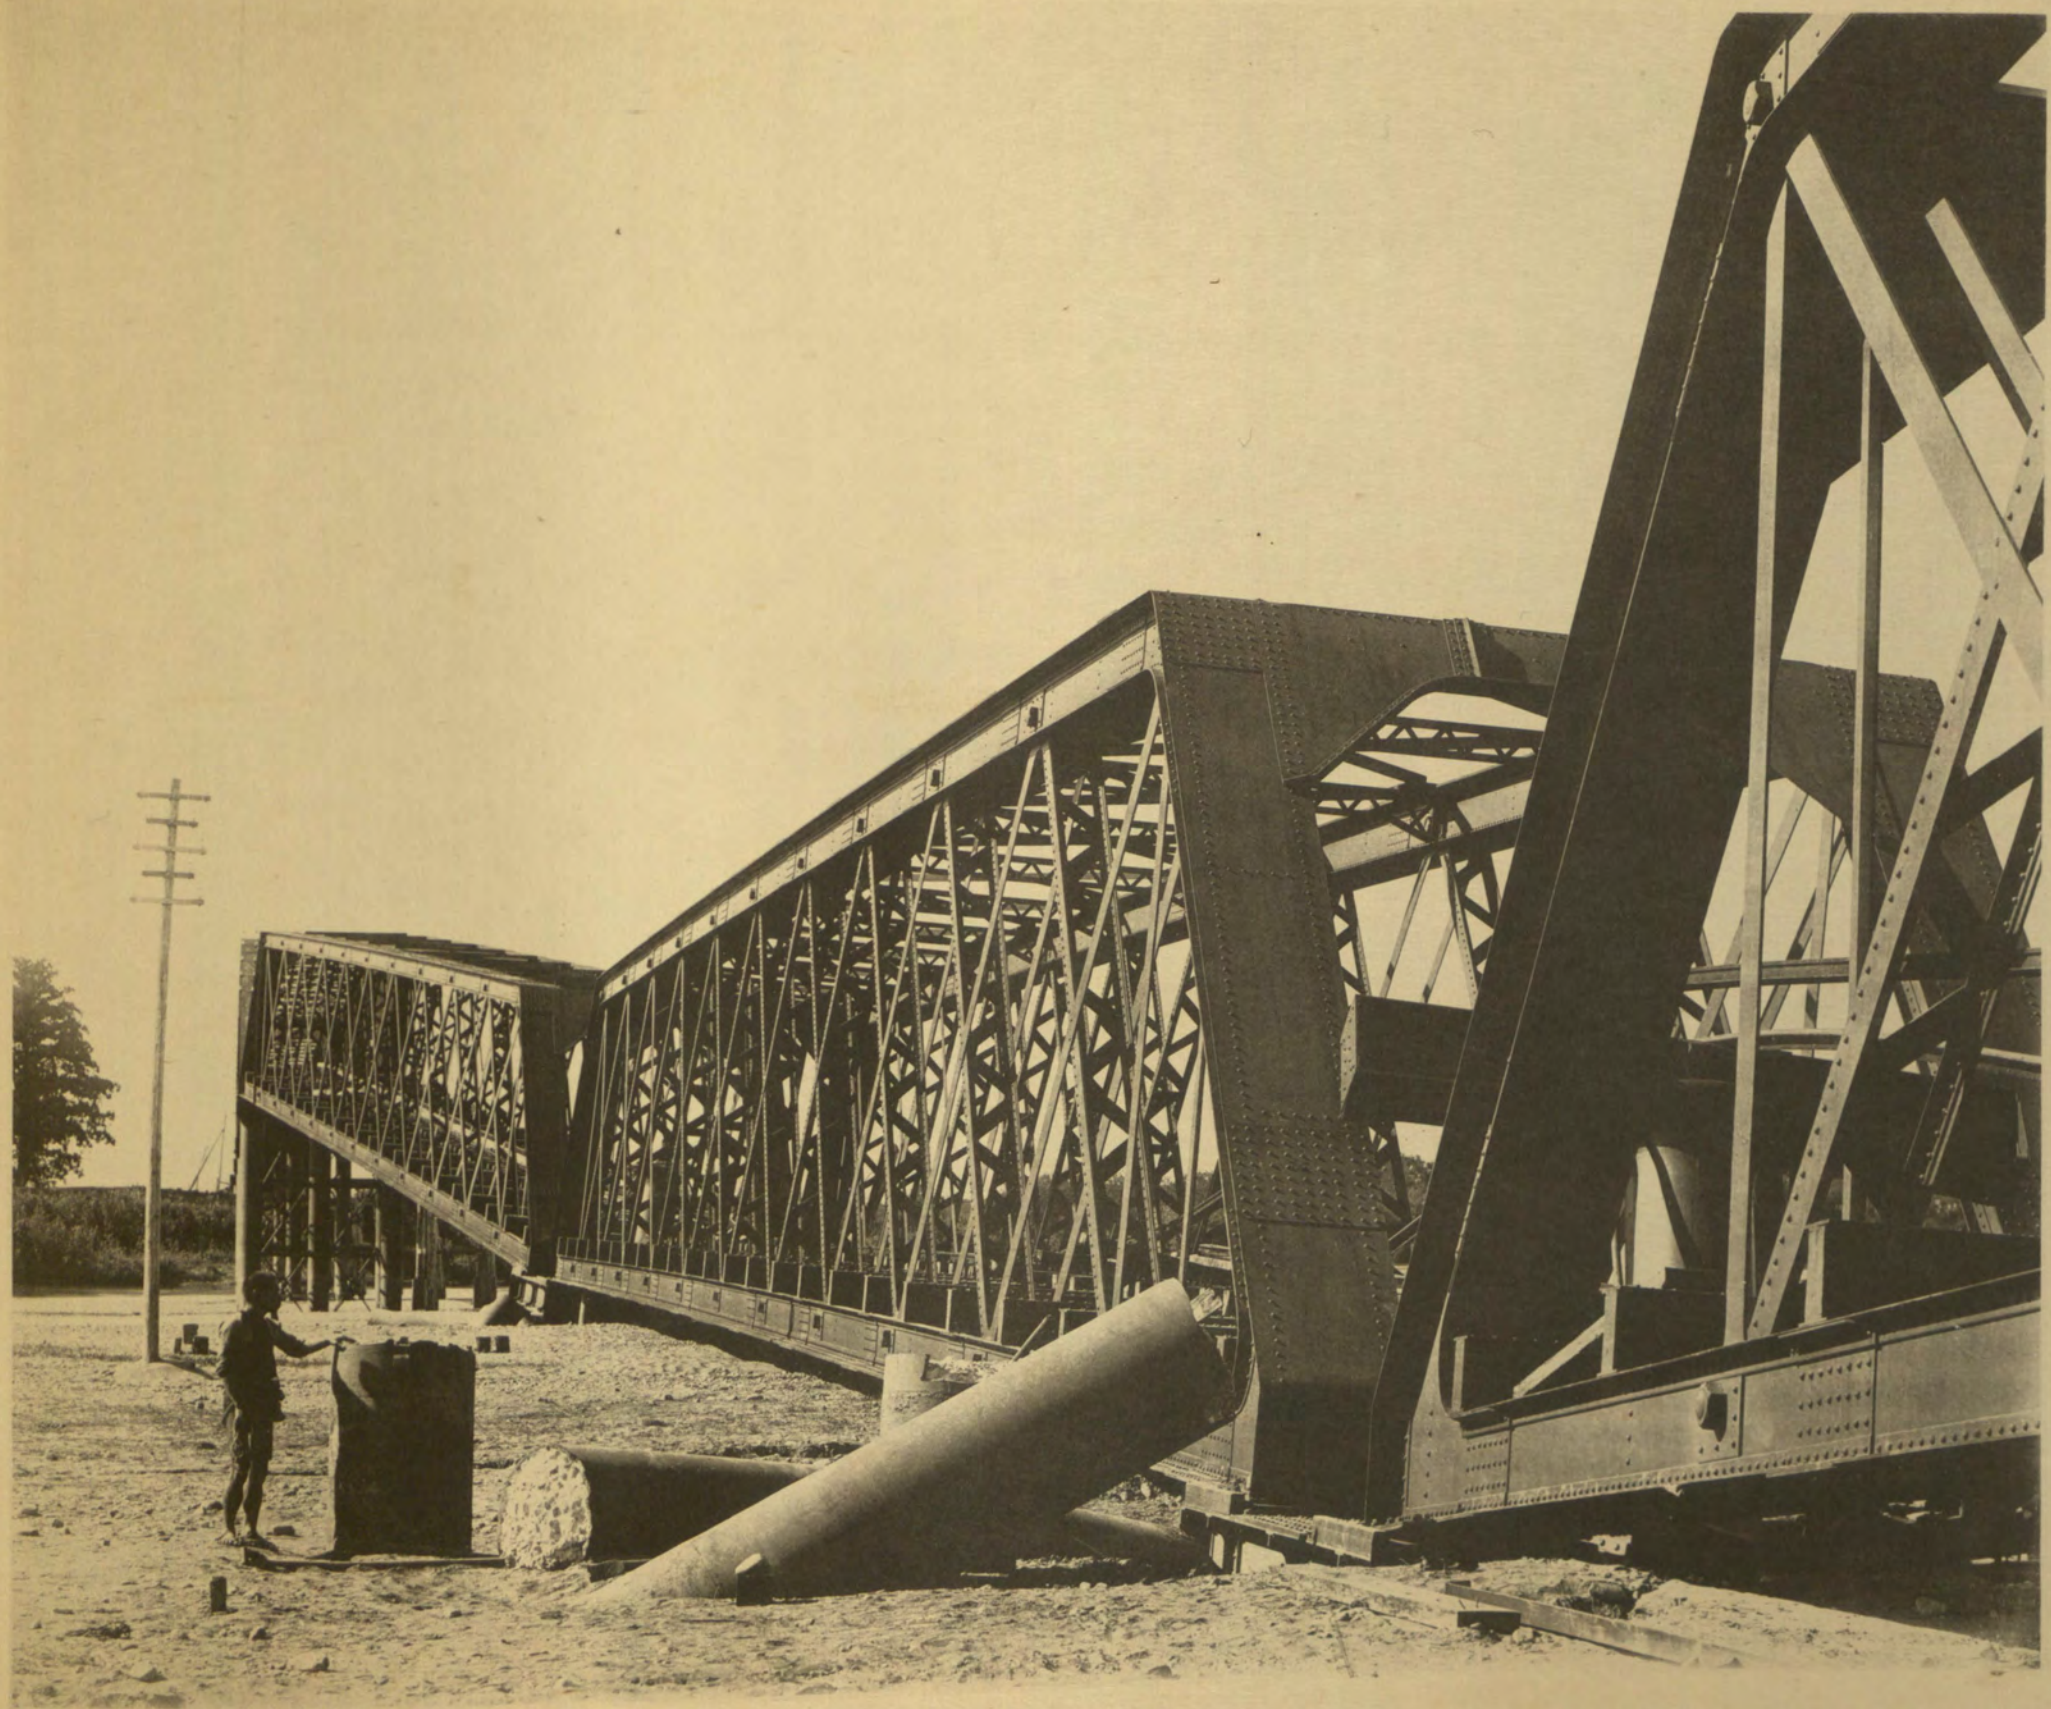
PLATE XXIII.

The cause of the collapse of this bridge is undoubtedly the failure of the piers. The girders, even those that have fallen, appear, on a casual inspection, to be straight and intact.

It will again be observed that the portion of the bridge which has fallen, relatively to the part which remains standing, has been thrown some distance out of a straight line.

Examination has shewn that this displacement, is not simply a displacement of the upper-work of the bridge, but the ground with the screw-pile foundations has been shifted a distance of several feet up the stream.

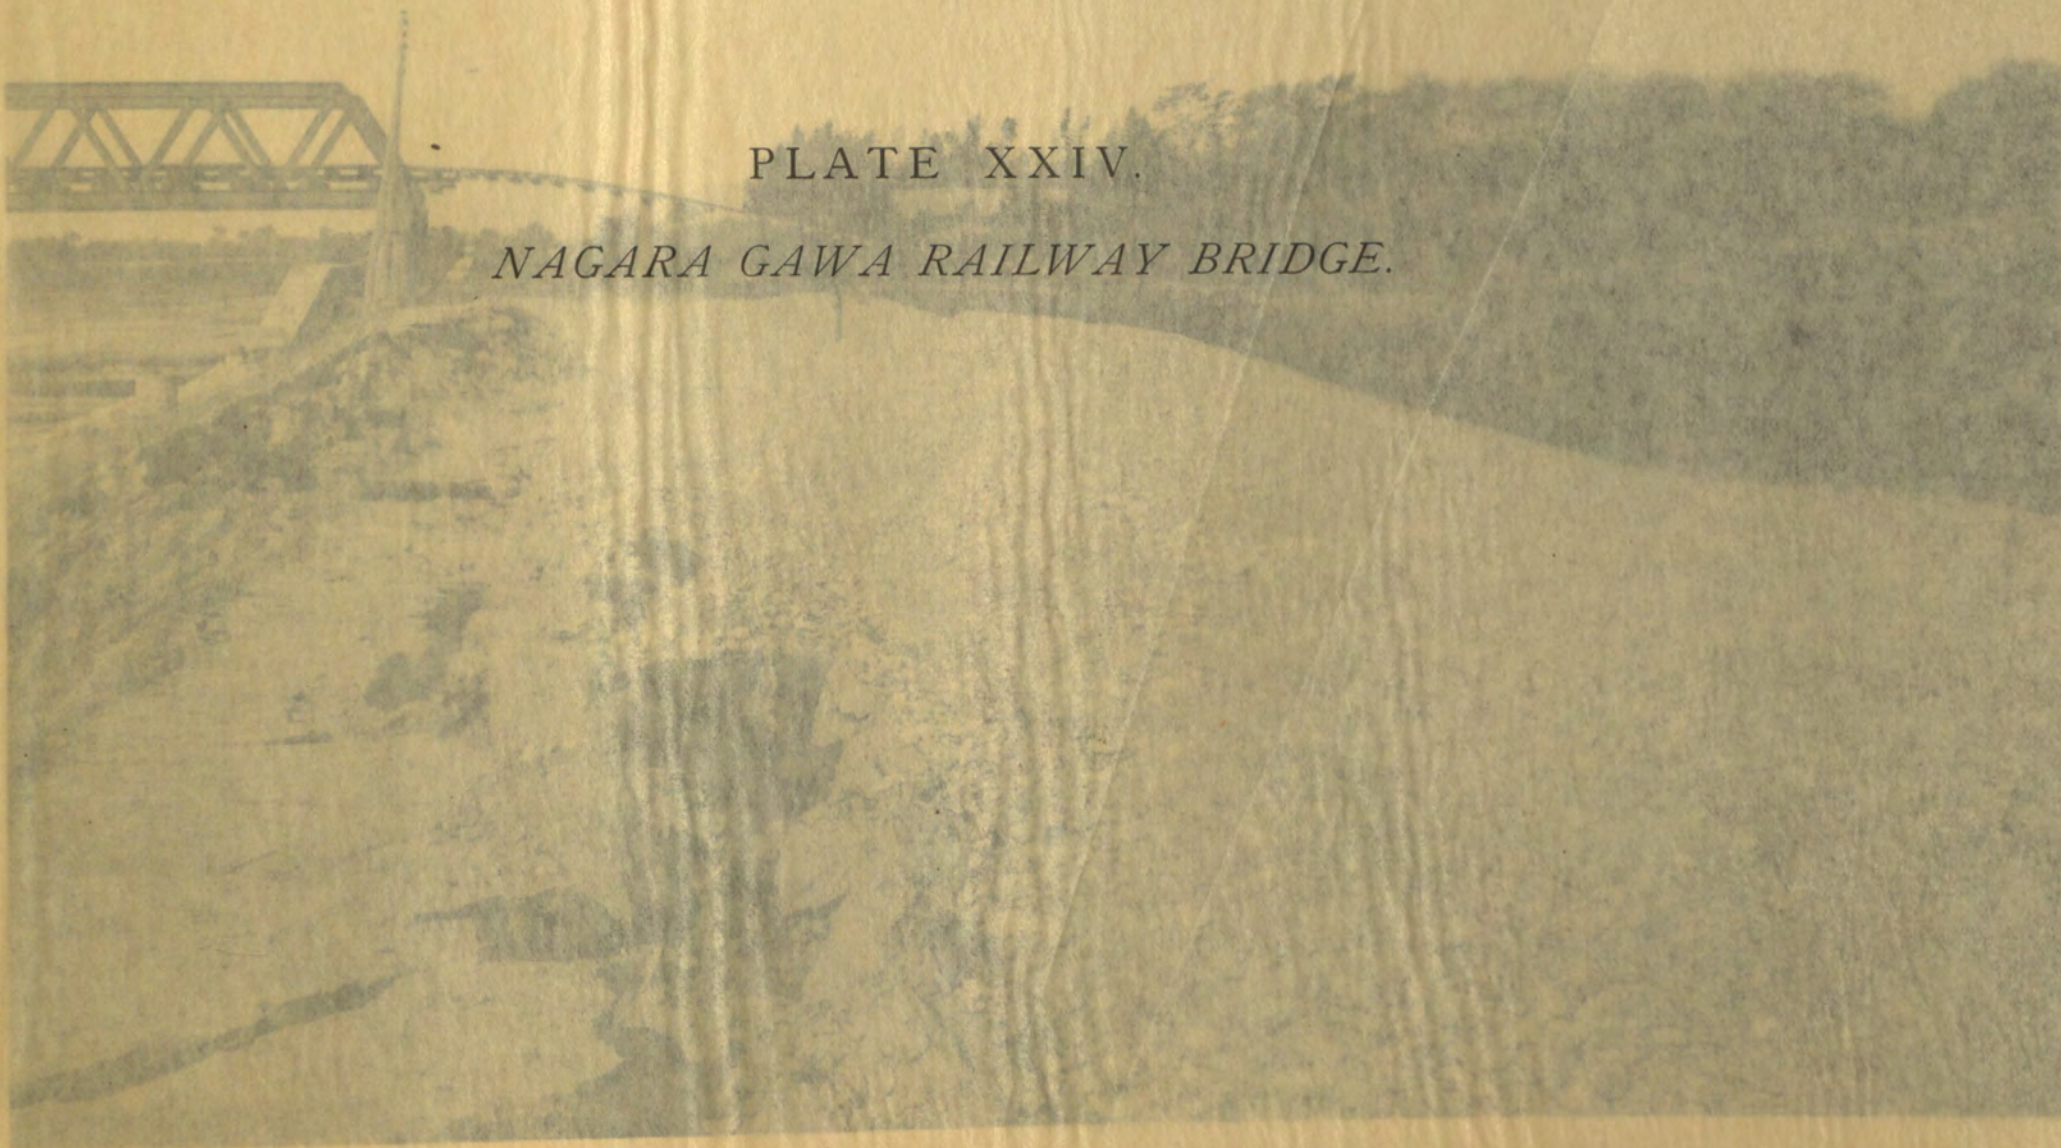
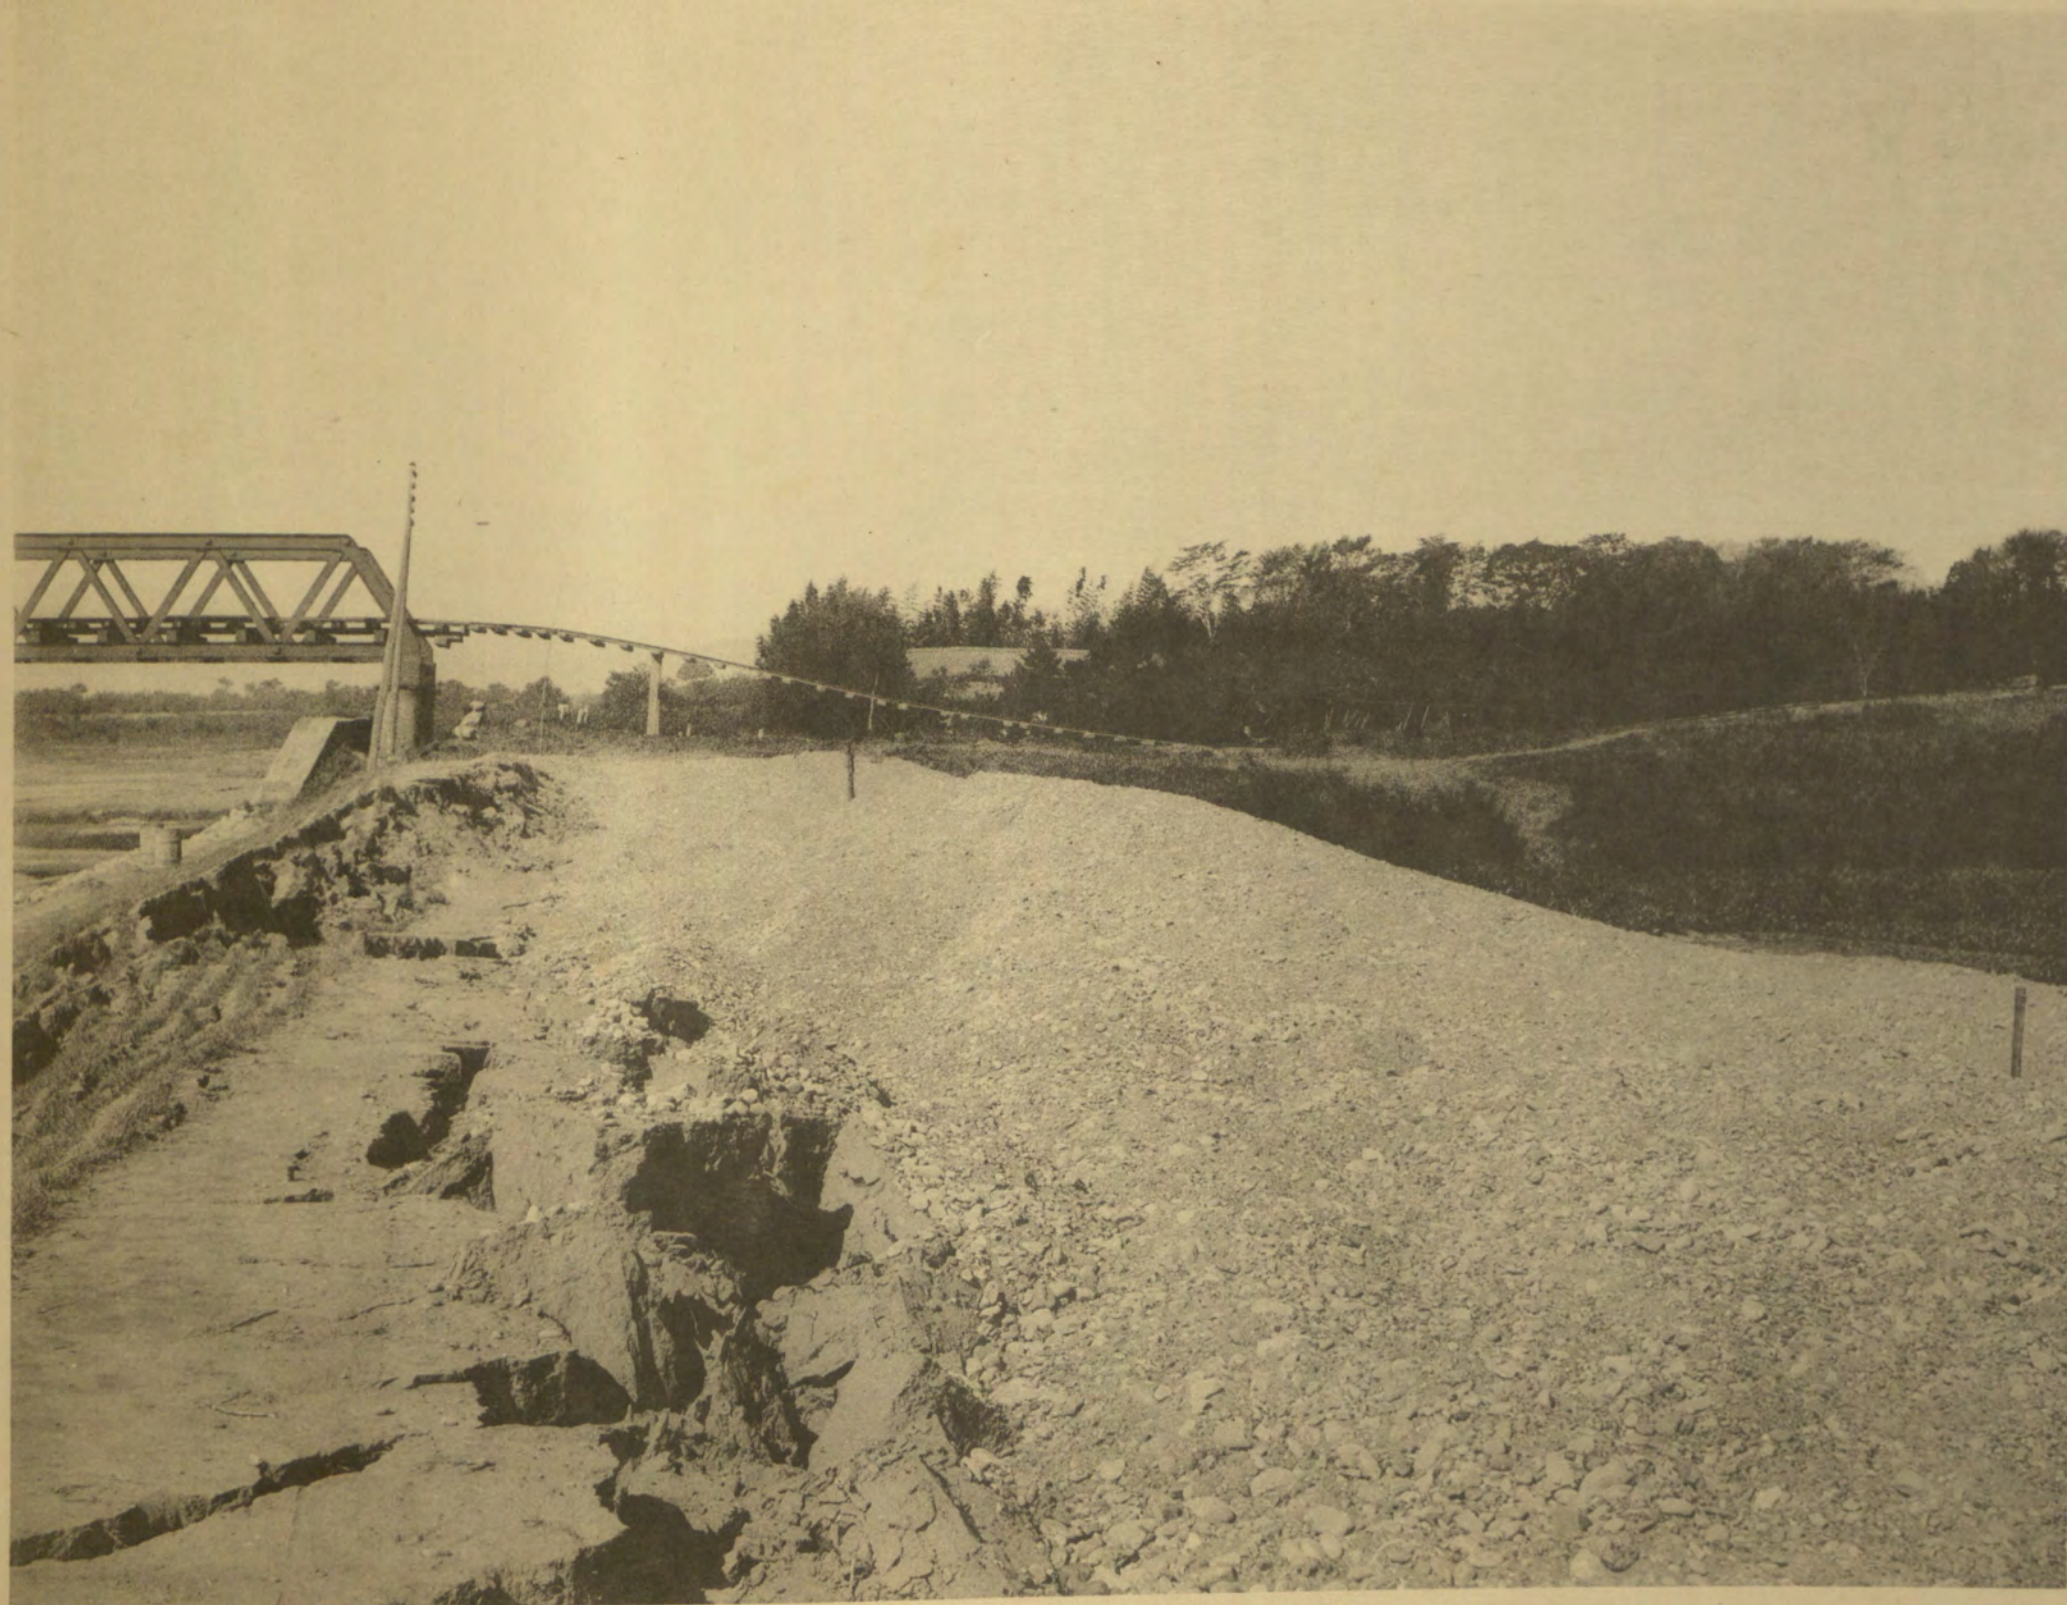
PLATE XXIV.

The disappearance of embankments, as for instance near to the abutments of many bridges, is undoubtedly due to the shaking away of the loosely cohering materials out of which they were constructed.

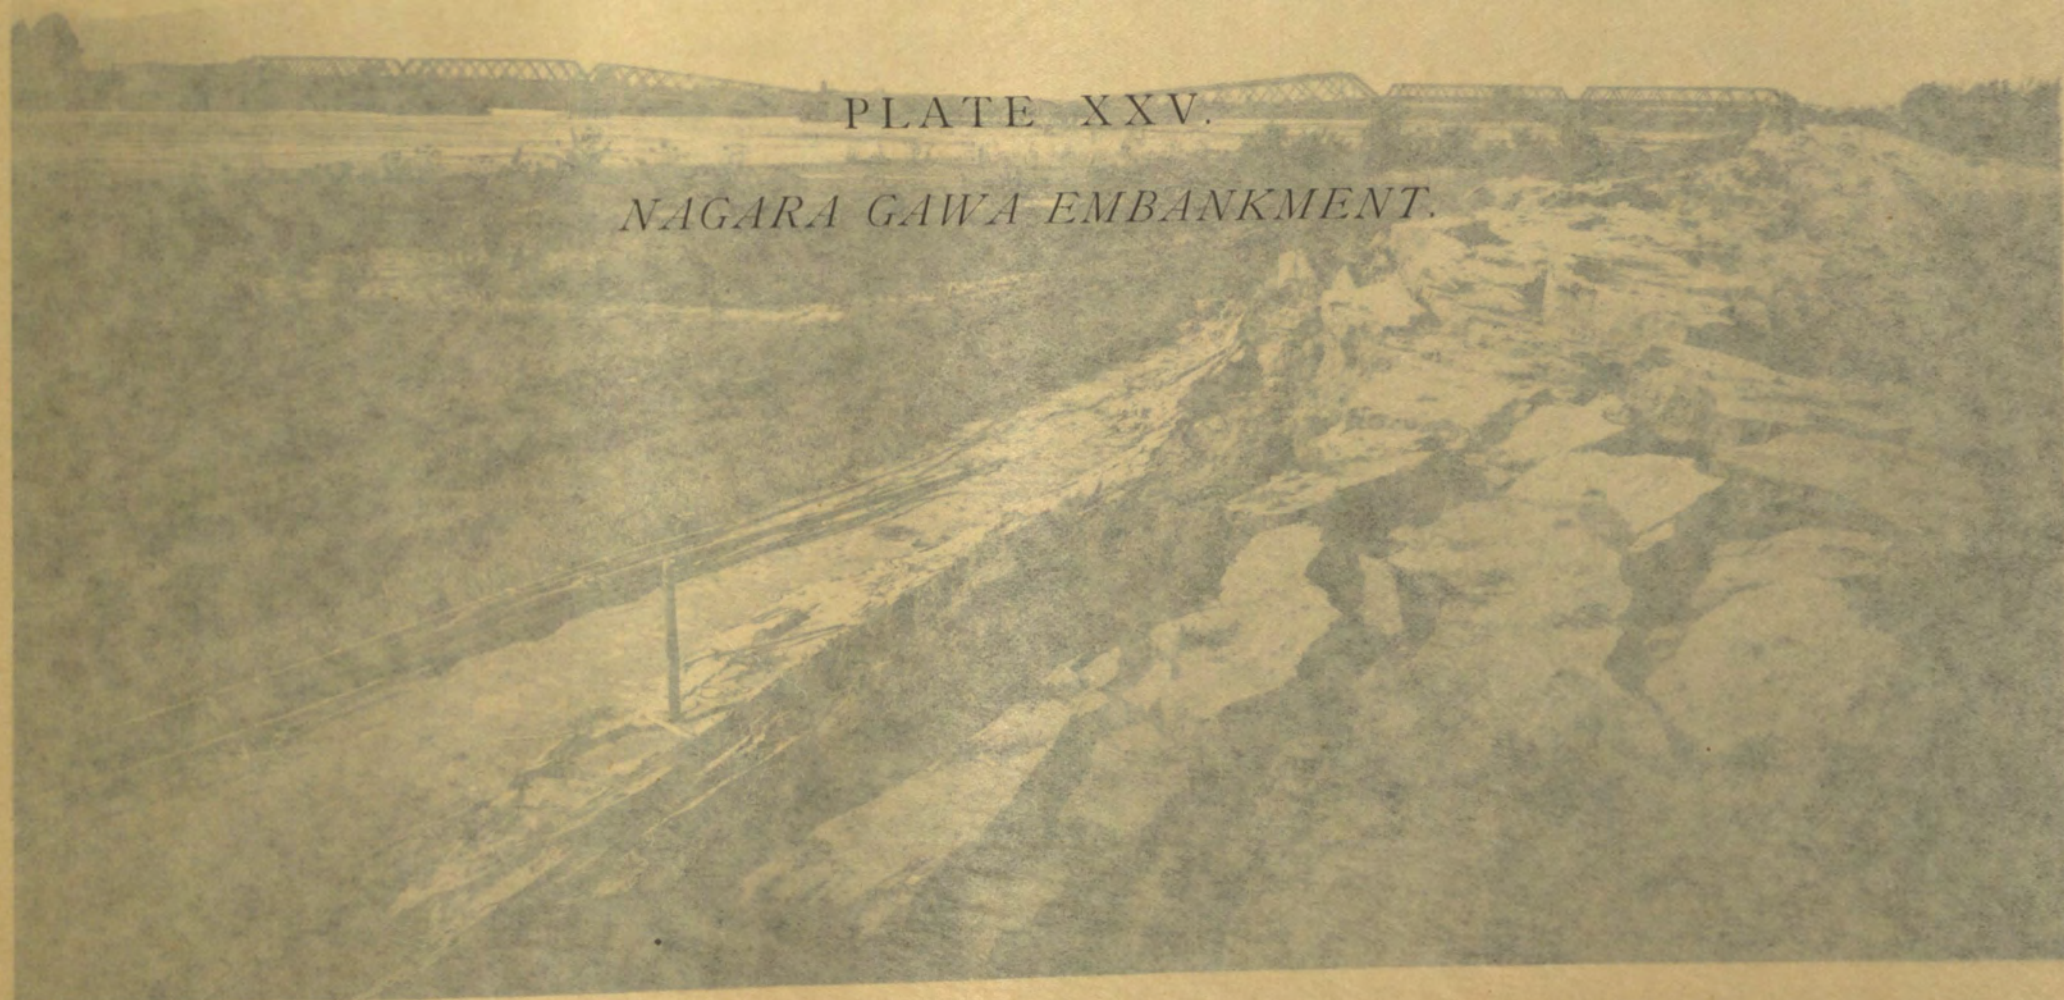
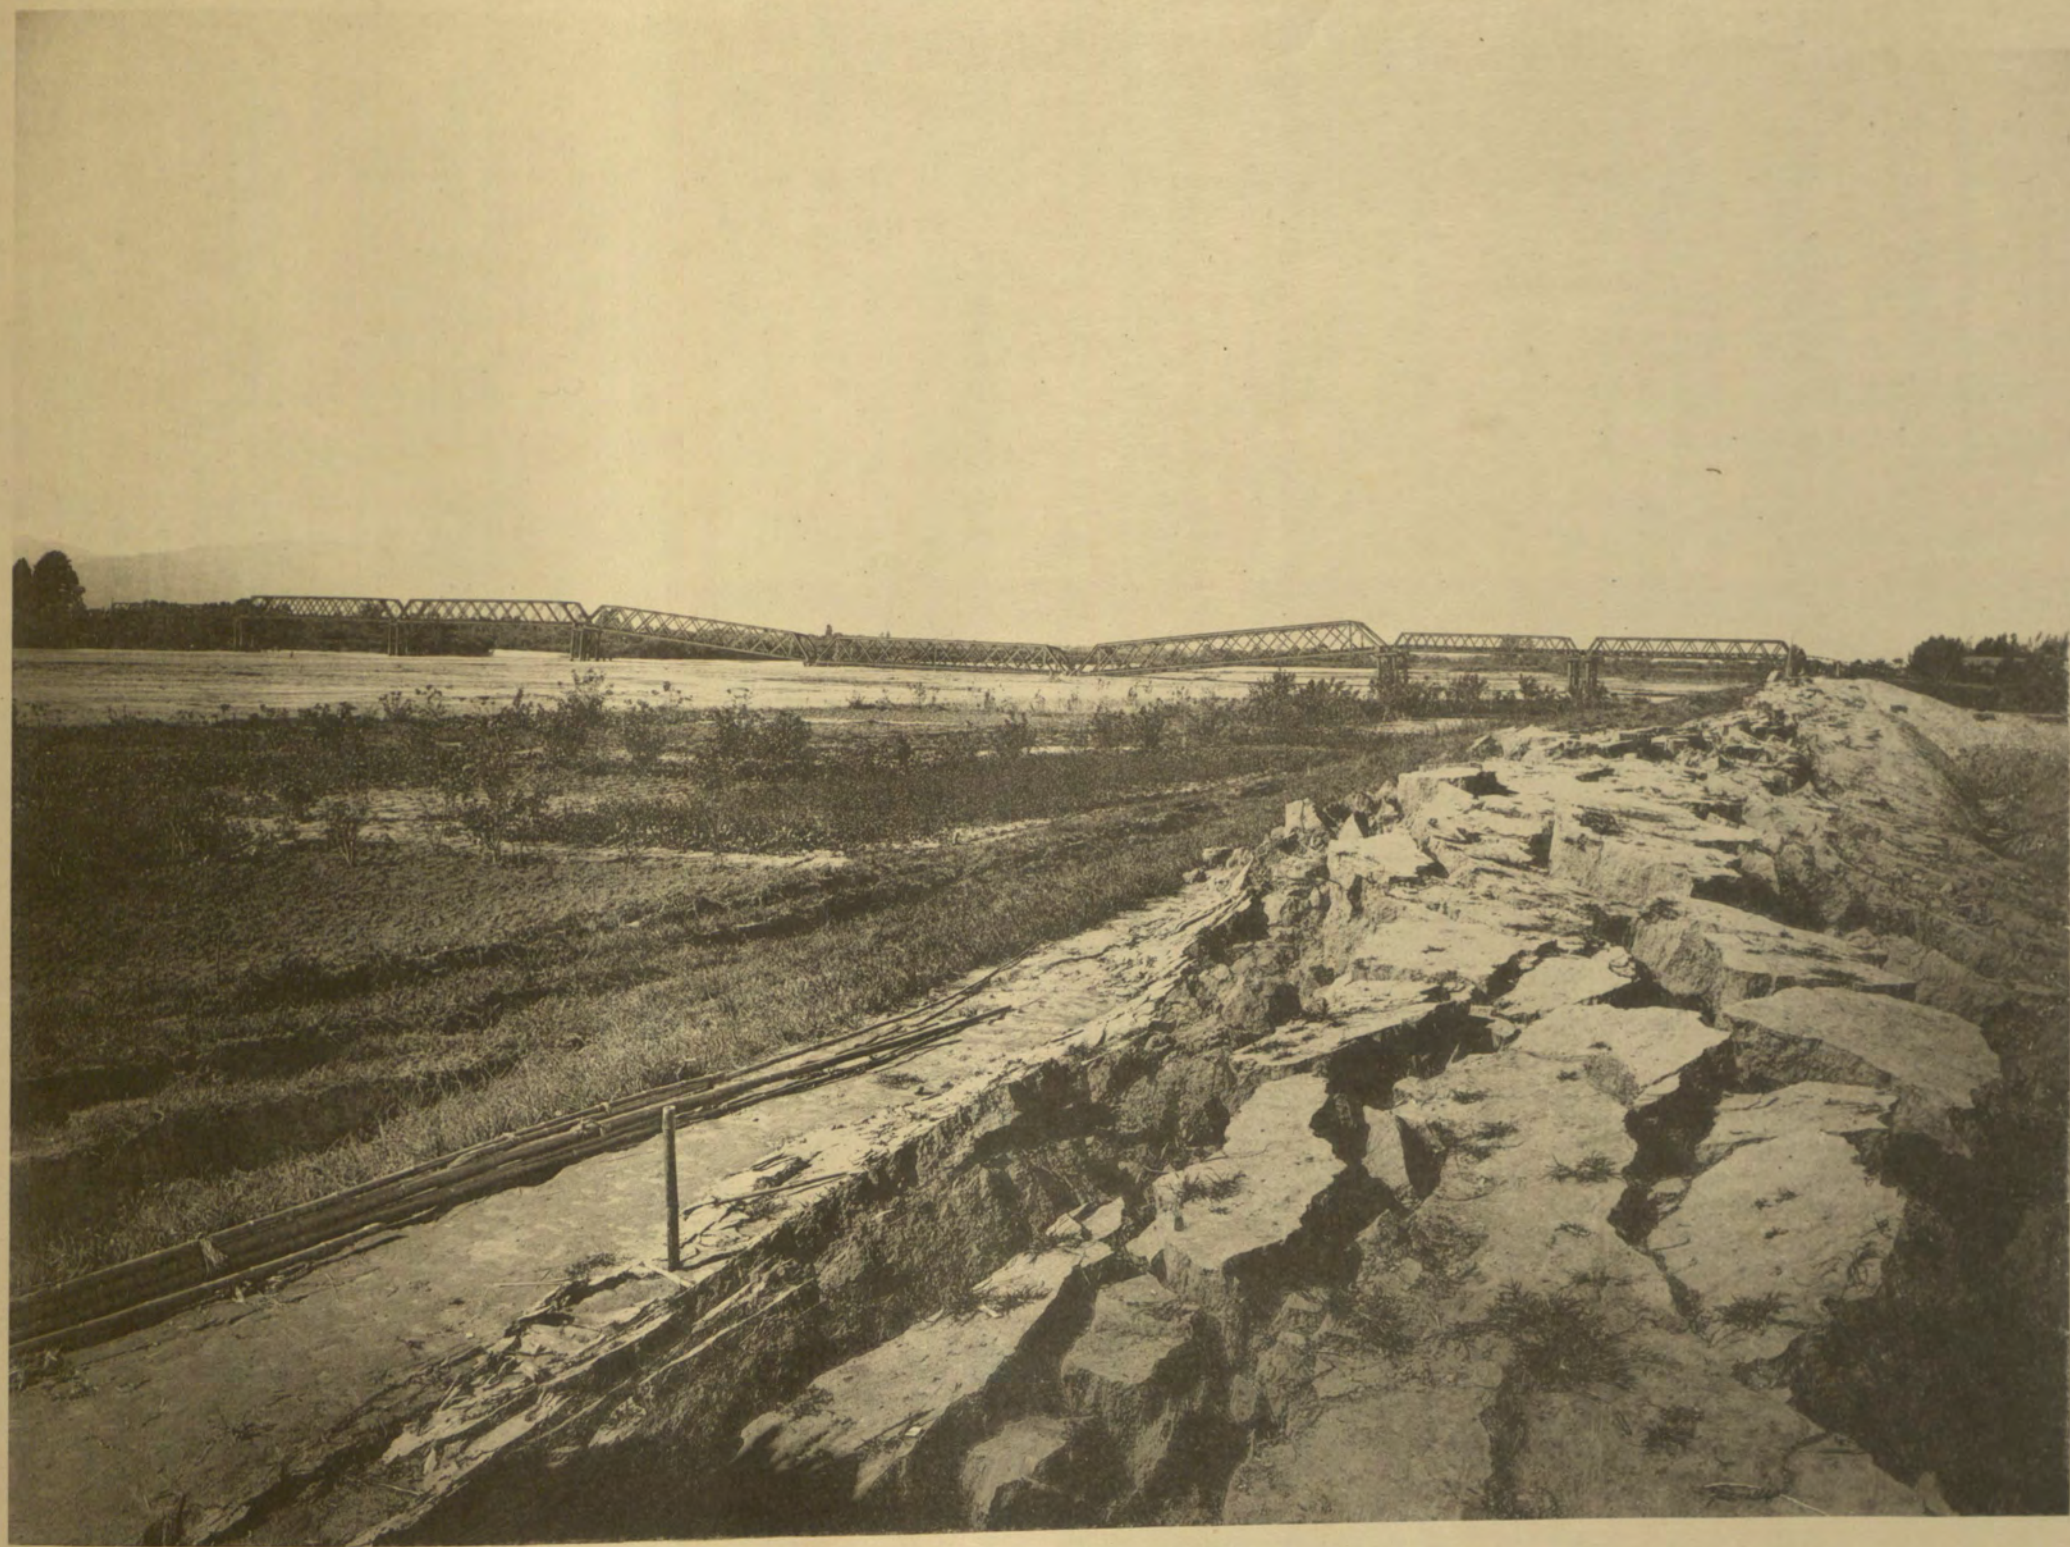
PLATE XXV.

The longer piers have suffered most. When looking at the illustrations of the railway bridges which were designed by Mr. C. A. W. Pownall, M.I.C.E. it must be remembered, that, for five years, not only have they withstood all ordinary traffic, but they have been subjected without injury to unusually heavy floods, which have devastated the surrounding country, and have withstood the force of typhoons which have overturned locomotives and caused the collapse of many brick chimneys and buildings.

Where river banks have not been levelled by the shaking outwards of the materials of which they were built, they have been fissured and reduced to the chaotic state shewn in the picture.
